# Detecting an improperly-lubricated journal bearing in a centrifugal compressor (when your 'toolbox' isn't full)

by Karl Enge, P.E.

### High vibration on plant air compressor

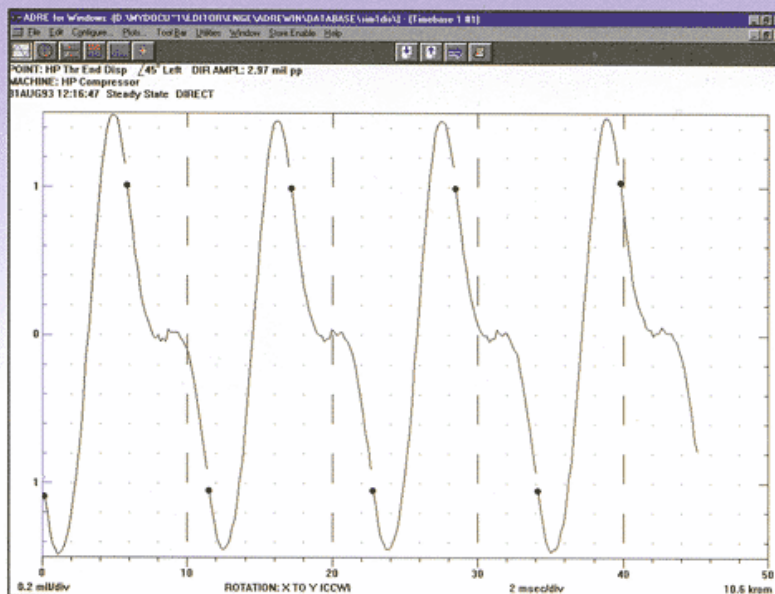
Figure 2  
Steady state shaft direct timebase plot, HP compressor thrust end (Bearing #4).

Note the large difference between the shaft and bearing cap direct amplitudes. The shaft vibration waveform plot (Figure 2) shows a definite, repeatable pattern. The shaft vibration half spectrum plot (Figure 3) illustrates two predominant frequencies—a sub-synchronous component near 0.5X and the synchronous component at 1X. A component at 1.5X is also visible. The 0.5X, 1X, and 1.5X components in the bearing cap vibration half spectrum plot (Figure 4) occur at amplitudes close to the noise floor, indicating a low signal-to-noise ratio. It is clear from these plots that very little of the shaft vibration was being transmitted to the bearing caps. Data from the Seismoprobe transducers essentially contained no useful information.

Figure 2 shows that the Keyphasor marks on the waveform occur at the same location on each vibration cycle. Thus, the vibration was occurring at an integral sub-multiple of running speed; if the Keyphasor marks had drifted across the waveform pattern, then the vibration would not have been an integral submultiple. It was clear that the vibration was occurring at *exactly* 0.5X, rather than *about* 0.5X.

Vibration about 0.5X would be a symptom of a fluid whirl or whip instability. Vibration at exactly 0.5X tends to be a symptom of a rub or a loose, oversize, or improperly lubricated bearing (although fluid whirl/whip still cannot be ruled out). Orbit and full spectrum plots would have been useful in this case by providing information on the direction of vibration relative to shaft rotation (forward/reverse precession). A rub can exhibit either forward or reverse precession (depending on its severity), while loose, oversize, or improperly lubricated bearings and fluid whirl/whip exhibit forward precession.

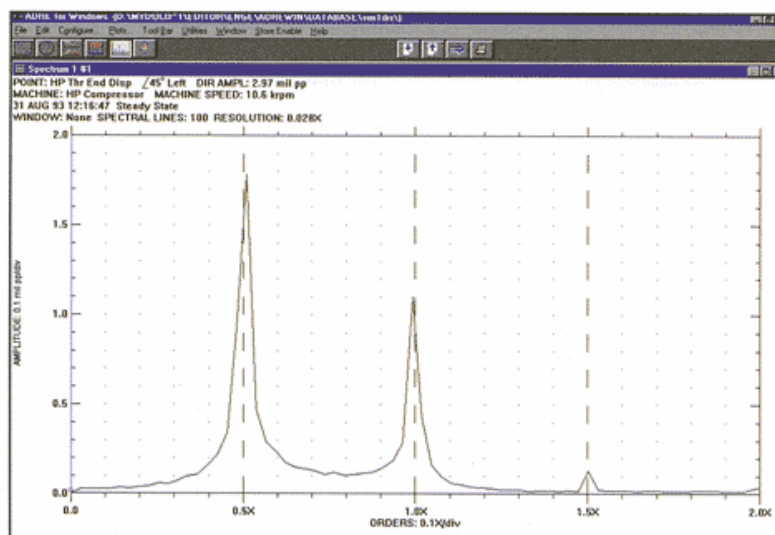
Figure 3  
Steady state shaft half spectrum plot, HP compressor thrust end (Bearing #4).

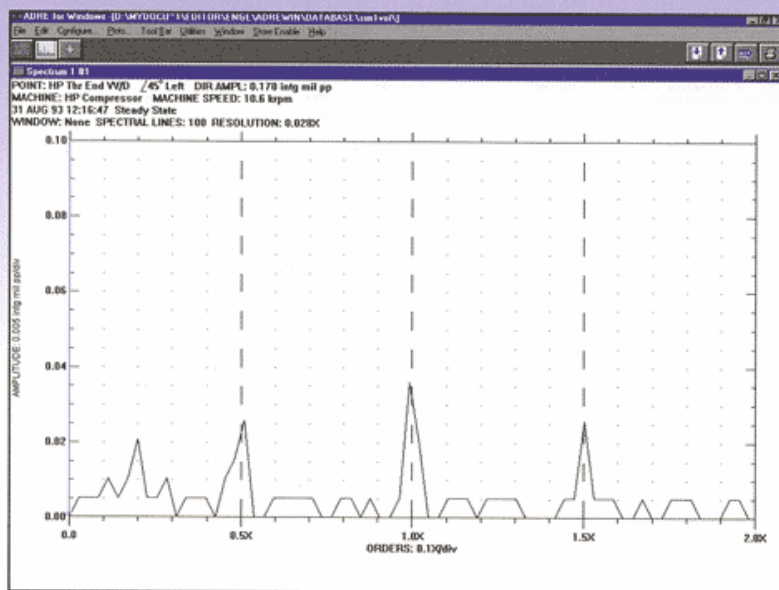
Figure 4

Steady state bearing cap half spectrum plot, HP compressor thrust end (Bearing #4).

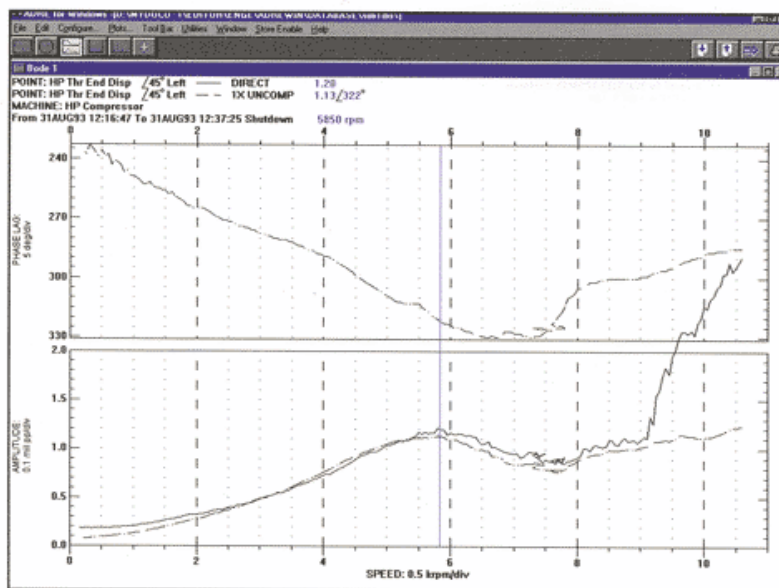
Figure 5

Initial shutdown Bode plot, HP compressor thrust end (Bearing #4).

1) The first balance resonance speed (critical speed) appeared to be at 5850 rpm (Figures 5 and 6). The design, or nameplate, balance resonance speed was reported to be at 6700 rpm. This reduction in the balance resonance speed was attributed to a decrease in the direct stiffness of the rotor/support system.

2) The 0.5X vibration dies out at speeds below 9150 rpm (Figures 5 and 7).

A rub could now be ruled out based on this information. A 0.5X rub occurs at machine speeds *above* twice the first balance resonance speed. In this case, a 0.5X rub might occur at speeds *above* 11,700 rpm; however, the 0.5X vibration was observed as low as 9150 rpm. In addition, rubs tend to *increase*, rather than *decrease*, the system's direct stiffness.

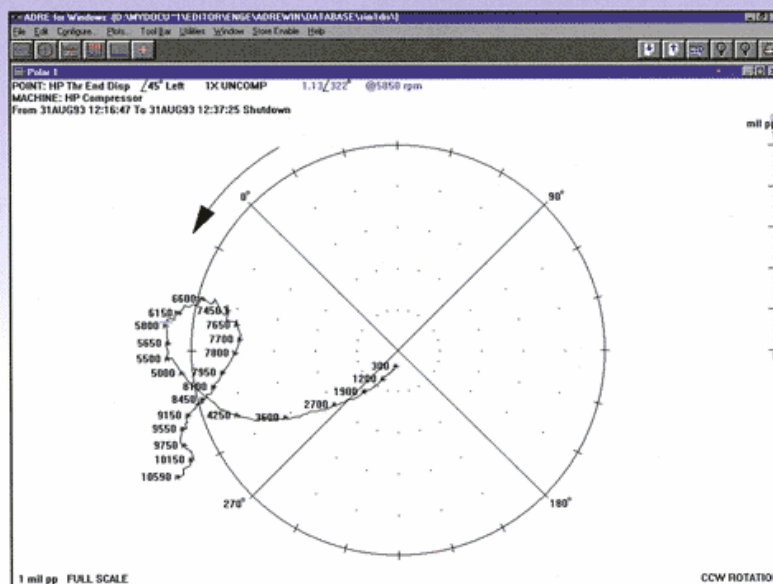
Figure 6  
Initial shutdown polar plot, HP compressor thrust end (Bearing #4).

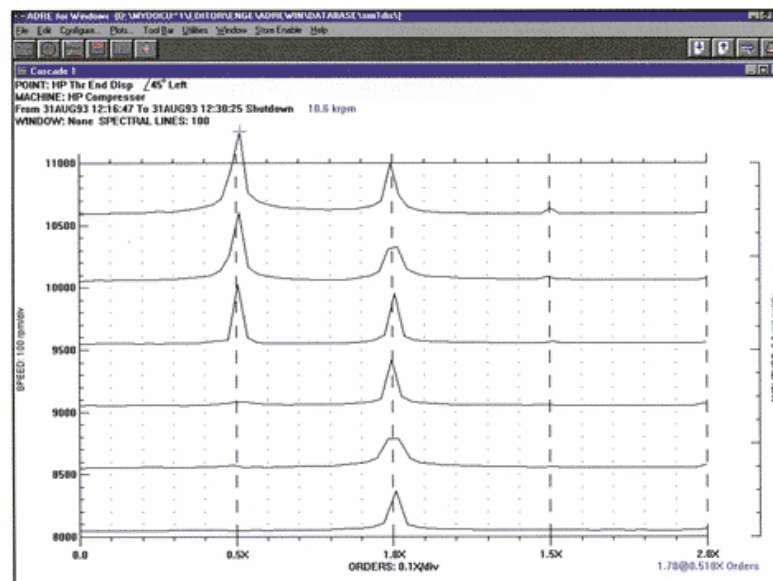
Figure 7  
Initial shutdown half spectrum cascade plot, HP compressor thrust end (Bearing #4).

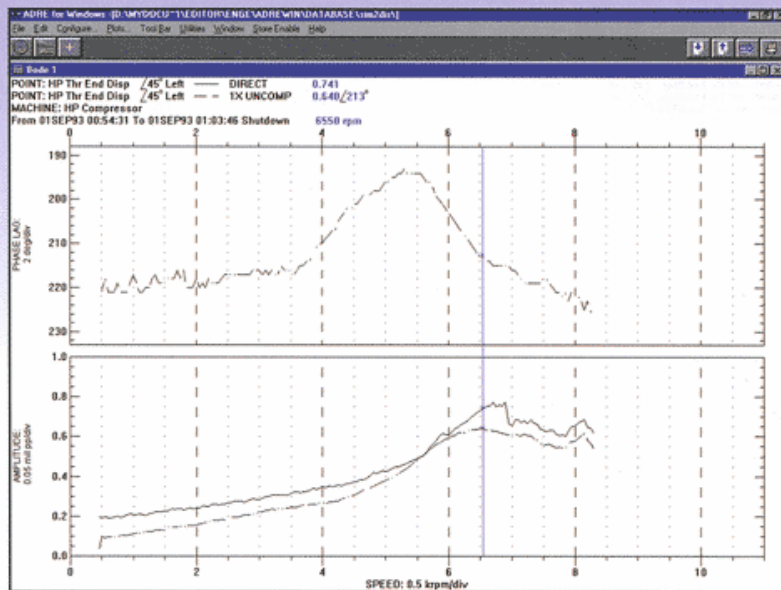
Figure 8

Shutdown Node plot (8300 to 100 rpm), HP compressor thrust end (Bearing #4).

The compressor train was restarted and brought up to 8300 rpm, shut down, and restarted and brought up to 10,599 rpm. Figures 8 and 9 document the 8300 to 100 rpm shutdown; Figures 10 and 11 document the second restart from 7000 to 10,599 rpm. Please note that these plots are from two separate runs. The numerical values of the phase readings are not consistent between runs because the TK16 Multiplier/Divider selected a different phase reference point for each run. Phase data from Figures 8 and 9 should not be directly compared to phase data from Figures 10 and 11.

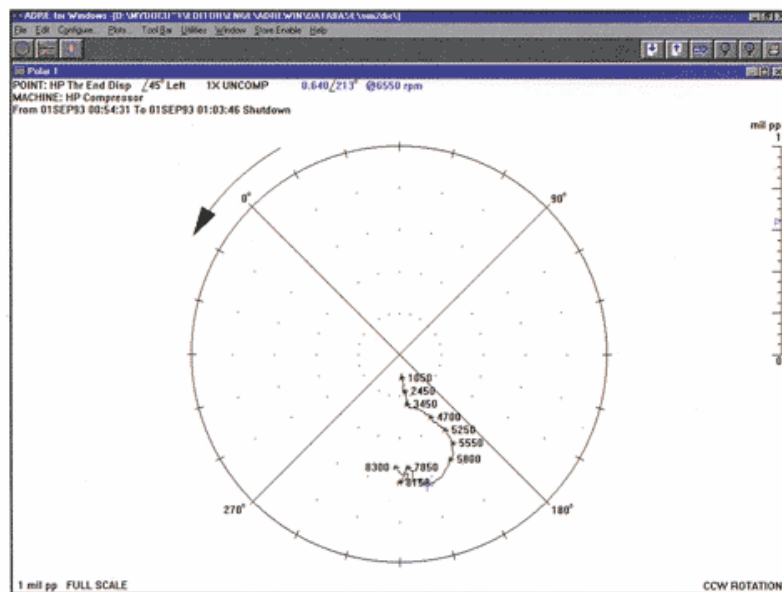
Figure 9

Shutdown polar plot (8300 to 100 rpm), HP compressor thrust end (Bearing #4).

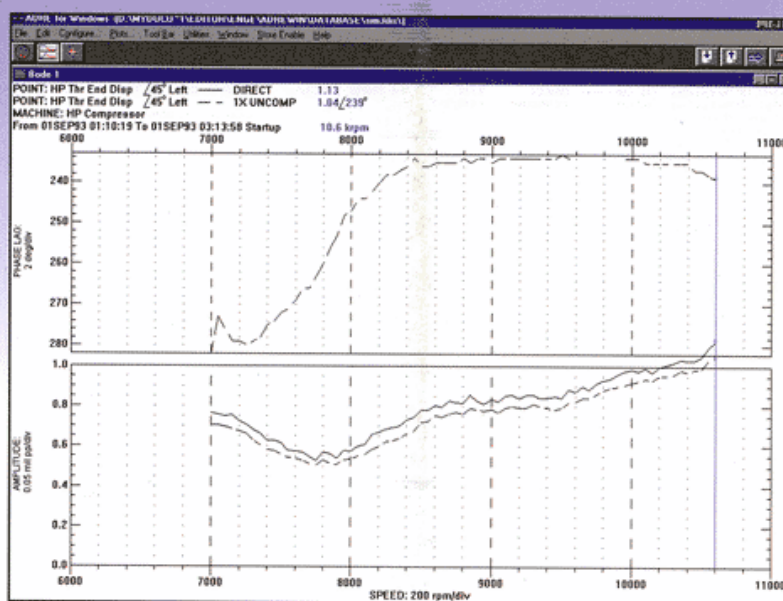
Figures 10 and 11 illustrate the decrease in the direct and 1X amplitudes which occurred above 9000 rpm after replacement of the bearing insert. There was no significant 0.5X vibration during this last restart. The final steady state shaft direct amplitudes at 10,595 rpm were 5.6  $\mu$ m (0.22 mil) pp at the non-thrust end (Bearing #3) and 30.0  $\mu$ m (1.18 mil) pp at the thrust end (Bearing #4). Figures 8 and 9 indicate that the first balance resonance speed shifted upwards, with the 1X uncompensated amplitude now peaking at 6550 rpm. The new balance resonance speed closely matched the nameplate balance resonance speed of 6700 rpm.

The observed phenomena could now be explained. It was likely the original, non-relieved bearing insert was improperly lubricated, which resulted in a fluid-induced instability. After it was replaced, the as-designed lubrication properties

Figure 10  
Restart Bode plot (7000 to 10,599 rpm), HP compressor thrust end (Bearing #4).

clearance; there was no oil groove. A correct bearing insert was located and installed.

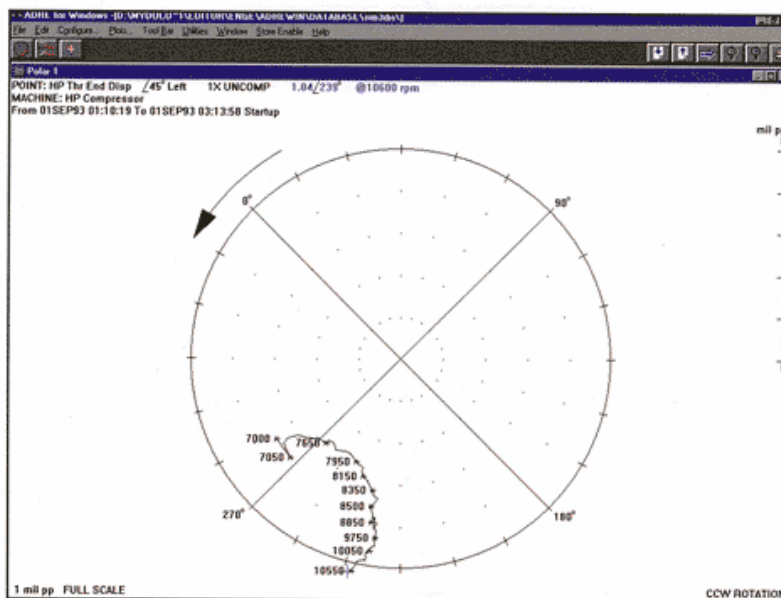
Figure 11  
Restart polar plot (7000 to 10,599 rpm), HP compressor thrust end (Bearing #4).
